PROPERTY INSPECTION REPORT

Prepared For:	Mary Smith			
	(Name of Client)			
Concerning:	1234 AnystreetBaytown			
	(Address or Other Identification of Inspected Property)			
	Kevin Plante TREC# 3552	01/27/2022		
	(Name and License Number of Inspection)	(Date)		
	(Name, License Number and Signature of Sponsoring Inspector, if required)

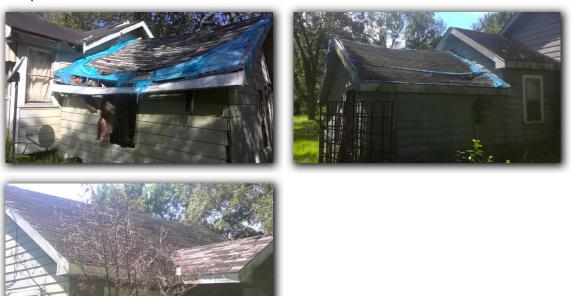
There are curled, brittle and damaged shingles observed at the Front and Back roof planes and ridge. This is an indication that the roof appears to be past the end of a typical life cycle and should warrant a full replacement. Consult a roofing contractor to make any needed repairs.

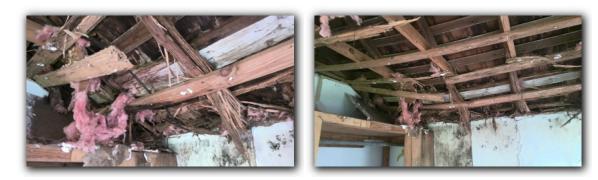
• There are cracked and damaged roof rafters at the left side front and back roof plane. There is excessive wood destroying insect damaged observed at the area rafters and roof decking. Any damaged roof rafters should be repaired and properly reinforced. Consult a framing contractor to make any needed repairs.

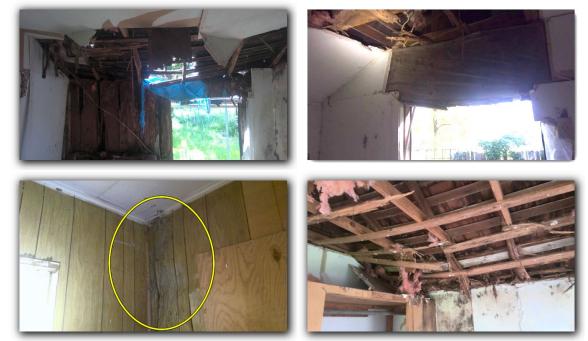
• There were sections of damaged and missing drywall observed at the Living Room and front Bedroom ceiling. Any missing or damaged drywall should be repaired and finished to match.

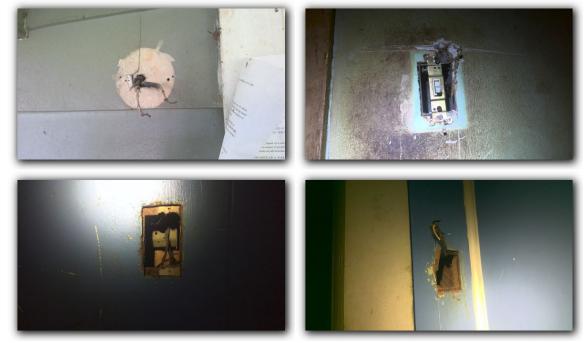
• There are cut power supply circuits throughout. There are missing light fixtures, outlets and switches observed throughout. The missing fixtures, switches and outlets should be replaced. The house wiring should be fully replaced. Consult an electrician to make any needed repairs.
